Bay Area Property Inspections, LLC

PRELIMINARY HABITABILITY INSPECTION REPORT

Golden Gate Village - Cole Drive, Representative Apartments, Sausalito, CA 94965

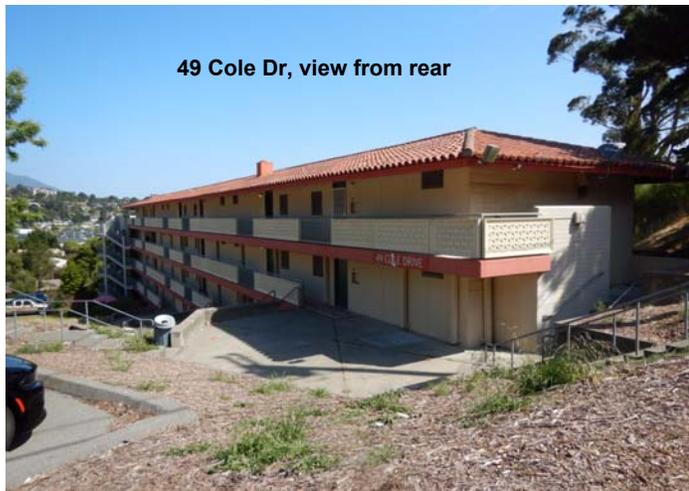
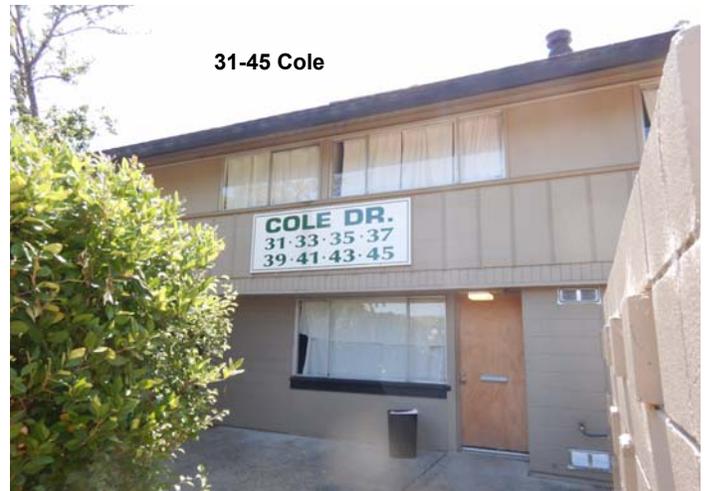
49 Cole and 69 Cole are representative of the "high rise" category of buildings in Golden Gate Village. These buildings are primarily monolithic poured concrete structures. The foundation, basement foundation walls, vertical exterior walls, middle floor structures, and the interior walls between adjacent apartments, all consist of poured reinforced concrete assemblies.

We did not scrutinize all exterior surfaces, but the main expanses of the visible concrete assemblies are all generally in very good condition with no visible cracks and no efflorescence.

31-45 Cole is representative of the "low rise" category of buildings in the development. This category of building consists of Concrete Masonry Unit (CMU, or concrete block) lower walls, and wood framed exterior upper walls that are covered with exterior plywood siding, and horizontal wood and vertical batton siding.

The envelope of this building was generally functional and in acceptable condition, also with no visible cracking in the inspected areas.

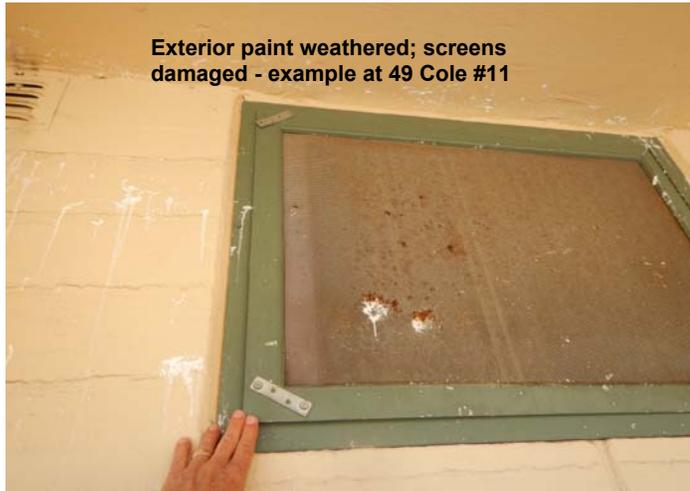
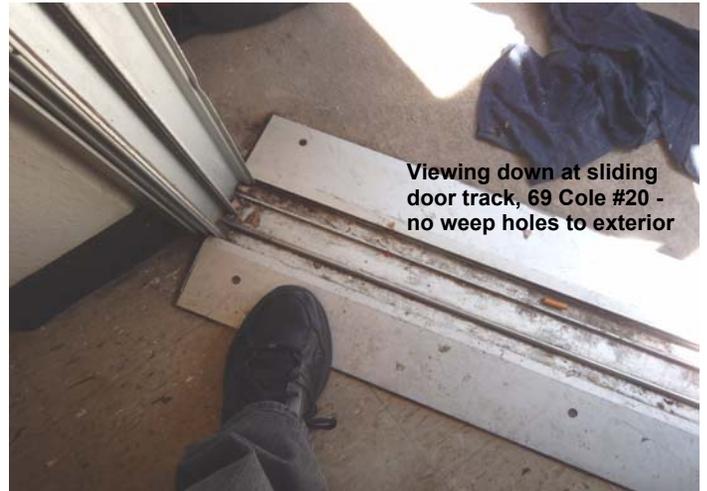
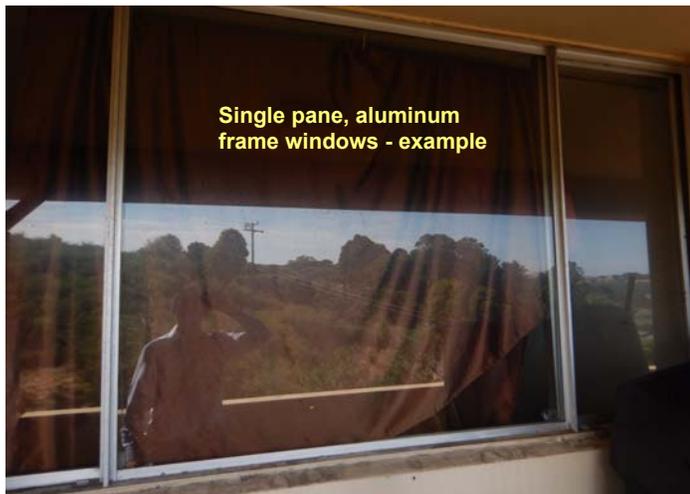
-- The balcony sliding door track in 69 Cole #20 does not include proper weep holes that would drain water to the exterior of the building, and as a consequence during heavy rains water leaks from the track into the dwelling space;

-- The single pane aluminum frame windows are in acceptable condition and do not appear to be leaking water. This type of window does not provide optimal energy efficiency, and are prone to interior condensation on the glass which often lead to mildew and mold on the interior metal frames and window sills;

-- The exterior window screens are generally damaged, although some have been repaired with brackets.

-- These issues may be pervasive. A licensed glazing contractor should thoroughly inspect all units, and then service or replace all exterior sliding doors and screens in order to assure proper and leak proof operation.

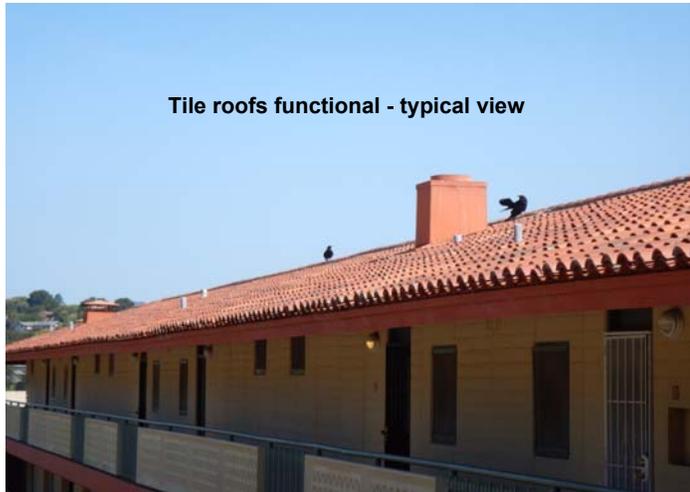
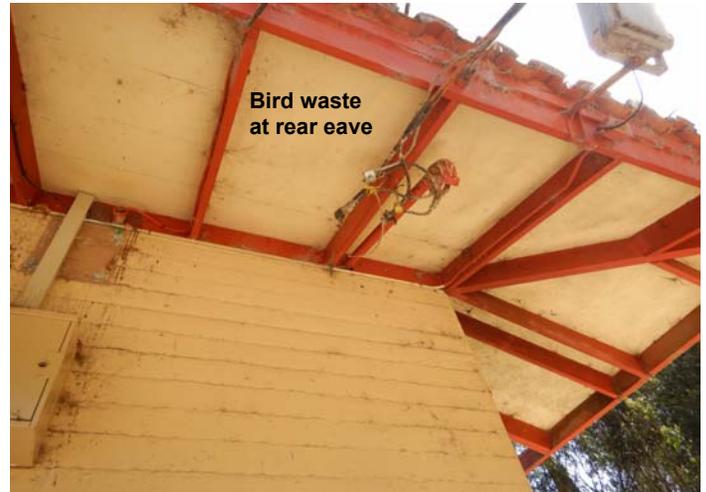
Copious amounts of bird waste are present below the rear eave of 69 Cole.

A licensed pest control operator should clean all such affected areas and install appropriate deterrent screening.

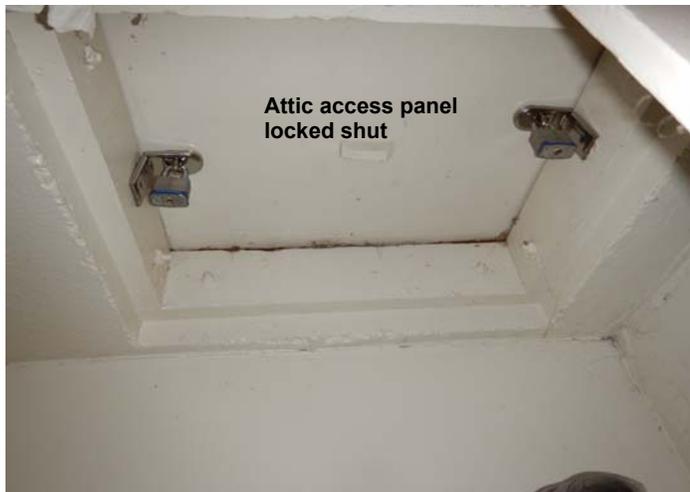
We could not inspect the attic above 69 Cole because the attic access panel was locked shut. Therefore we could not verify the presence nor quantity of insulation in the attic. Inadequate insulation will likely result in excessive heat loss during the cold seasons and expensive heating bills. In addition, inadequate insulation can cause excessive heat gain during the summer resulting in uncomfortably warm indoor conditions. Ceiling insulation is required by all current building standards, and we recommend installing as much as possible.

A qualified professional should remove the locks on the attic access panel and inspect the attic. If additional insulation should be added, a licensed insulation contractor should be retained to install appropriate material.

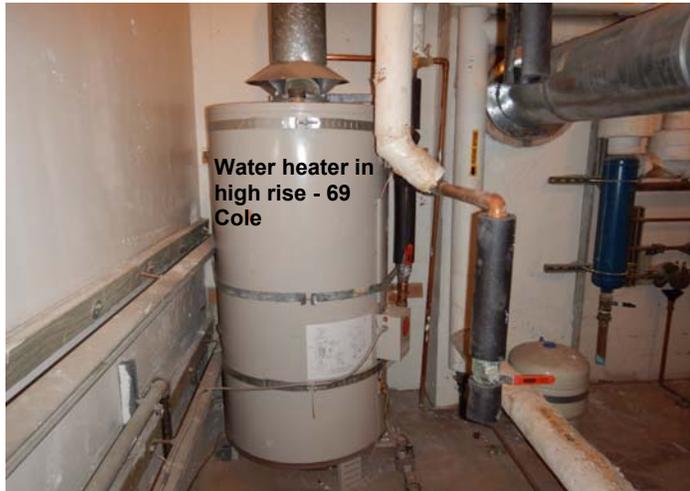
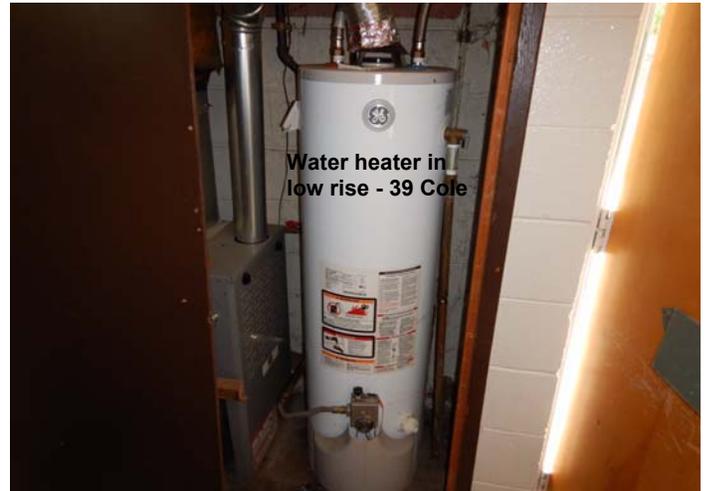
Hot Water - *Continued*

39 Cole is served by a 30 gallon, natural gas fueled, tank type water heater located in the utility closet. The water heater has the following conditions:

-- COMBUSTION AIR: The water heater/furnace closet does not include the currently required ventilation openings to the exterior of the building, and as a consequence both gas appliances use the dwelling space air for combustion which can adversely affect Indoor Air Quality;

-- HOOD: The draft hood connector is not secured to the water heater with screws, and could become dislodged allowing combustion gases to escape;

-- VENT: The vent connector is not secured to draft hood with screws, and could become dislodged allowing combustion gases to escape;

The vent pipe has no collar at the ceiling, which creates a potential fire hazard;

-- PIPES: The water pipe connectors are not insulated, and will lose heat;

-- BONDING: The hot water, cold water, and gas pipes are not electrically bonded together with copper wire to prevent electricity from passing through the pipes;

-- GAS: The gas valve has no sediment trap preceding it to remove debris from the natural gas fuel, as required by current standards and by the manufacturer's installation instructions;

The gas pipe is not properly secured near the water heater and could loosen, causing a gas leak;

-- TP VALVE: The discharge pipe from the Temperature and Pressure Relief Valve does not properly extend outside of the home as required; if the valve discharges, high pressure scalding hot water might be blasting out near the water heater and might prevent safe access to the heater;

-- STRAPS: The water heater is not seismically secured in an approved manner with two wide steel straps bolted to the house walls and blocking to prevent backwards movement, and might become dislodged during an earthquake, causing leaks, flooding, or fire.

-- PAN: The water heater is located on an interior floor but does not have a drip pan with a discharge pipe to the exterior of the dwelling as required to prevent damage caused by a water heater leak;

These conditions may be pervasive. A licensed plumber should inspect every water heater and service or replace it to comply with current standards.

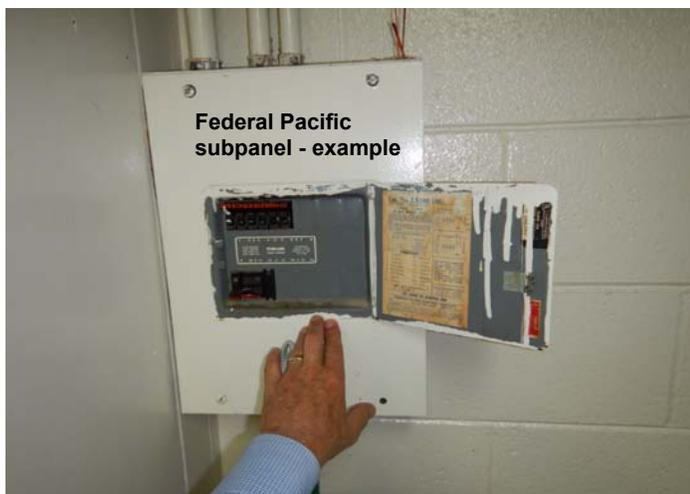
Each apartment unit contains an electrical subpanel manufactured by Federal Pacific. These panels are unsafe and unreliable due to the following defects: The circuit breakers may not reliably trip under load and therefore may not reliably prevent electrical fires; the circuit breakers may not properly disconnect the current even when they are manually switched off, and therefore may create a hazard of electrocution; the aluminum bus bars often become corroded which creates a fire hazard. The Federal Pacific company went out of business several decades ago.

A licensed electrician should replace every such subpanel with a new UL Approved panel in a manner that complies with current standards.

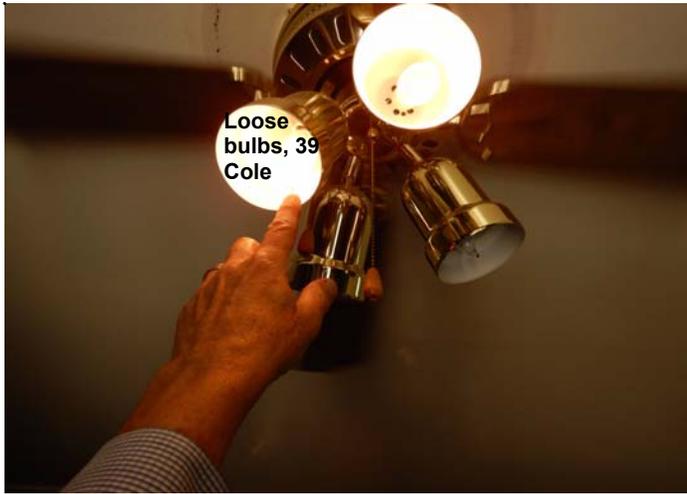
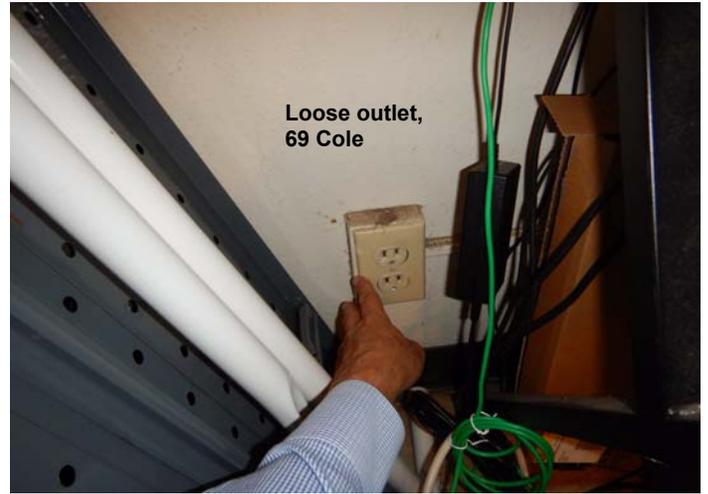
The interior wiring in the high rise buildings includes surface mounted EMT conduit and wire mold. Various light fixtures had loose bulbs, and various switches and outlets were loose or not functional. All such conditions create

A licensed electrician should thoroughly inspect and test the interior wiring in every unit, and service or replace all damaged or defective components.

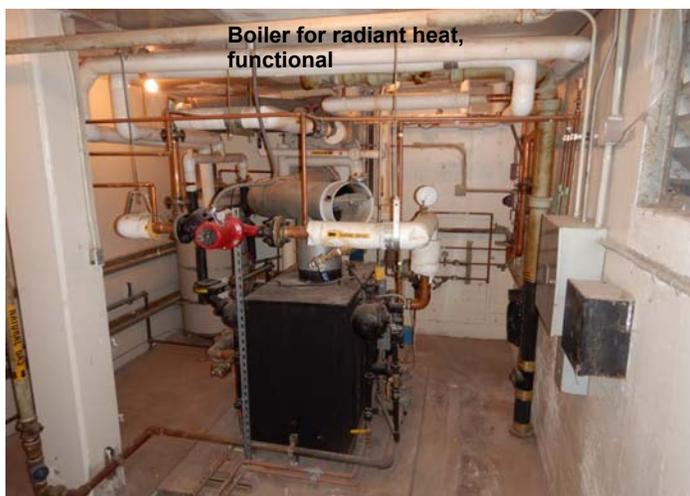
Each of the high rise buildings is served by a hydronic radiant heating system that includes a natural gas fueled boiler in the utility room, such as that in 69 Cole, and wall mounted radiators in each dwelling room in each apartment unit. The boiler in 69 Cole was functional and in acceptable condition at the time of this inspection, but we do not pressure test radiant heat systems.

A licensed plumber with expertise in radiant heating should evaluate the boiler. Management disclosed that the equipment is serviced annually.

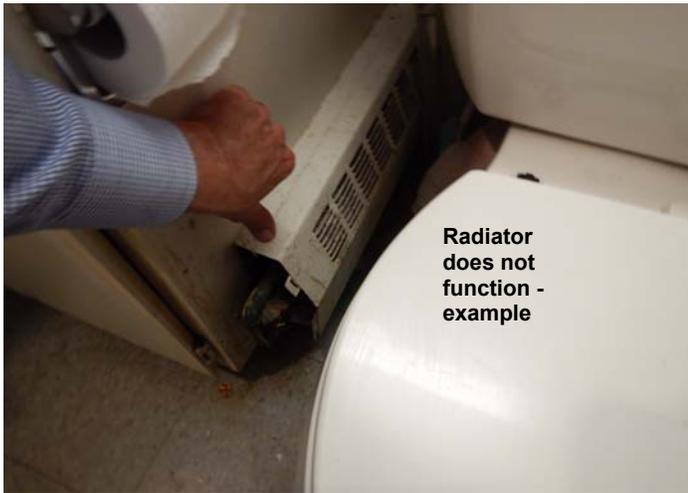
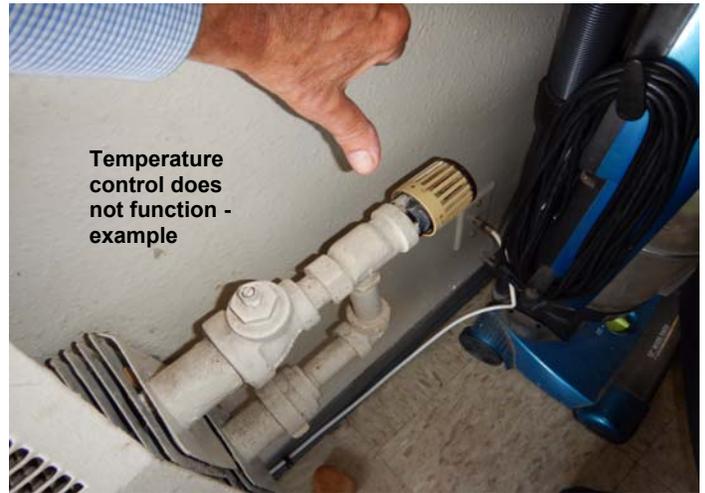
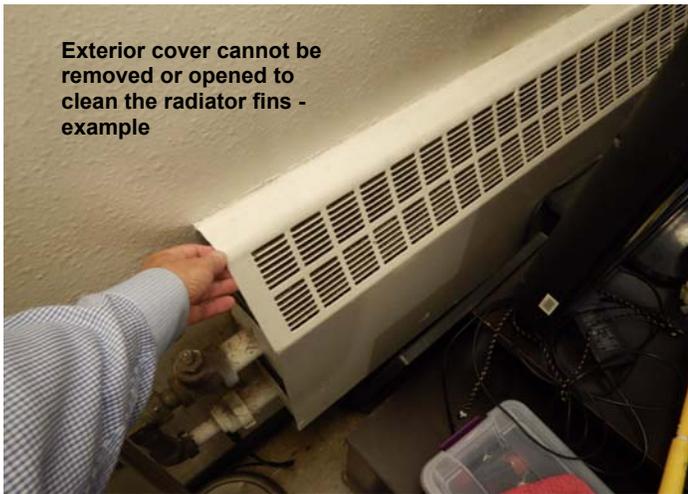
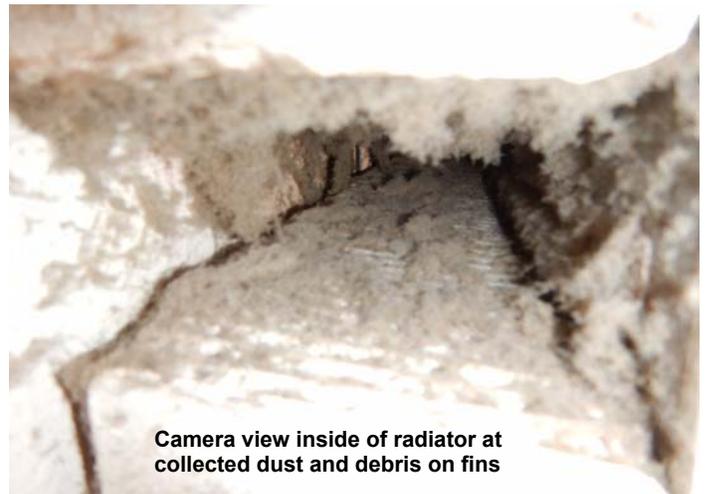
The interior hydronic radiators in the two inspected apartments had the following defects:

- Some radiators, such as in the bathrooms, did not function at all;
- The temperature controls on some radiators, such as that in 69 Cole, did not function, such that the radiators were On at all times, which is both wasteful and uncomfortable;
- The hot water pipes serving the radiators are not insulated nor protected, and could cause burns particularly to small children
- The sheet metal covers on the radiators cannot be opened nor removed in order to clean the coil fins, and as a consequence the fins are heavily coated with dust and debris that impede performance. In addition, the dust and debris can continually become airborne, creating poor Indoor Air Quality and causing respiratory symptoms.

A licensed plumber with radiant heat experience should service or replace the interior radiant heating components in an approved manner in order to correct all of these issues.

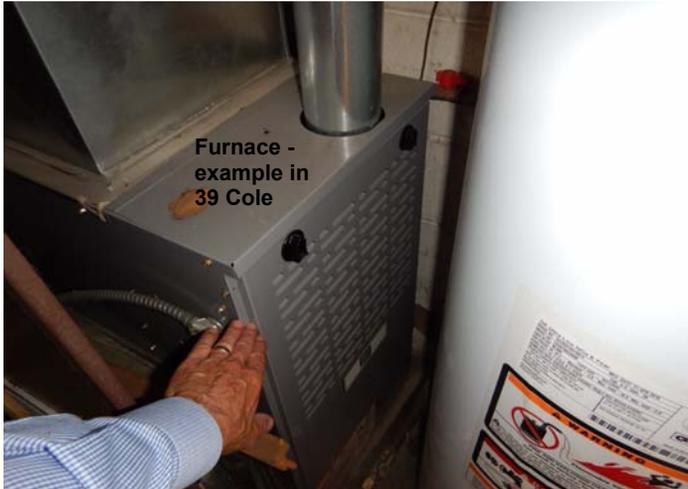
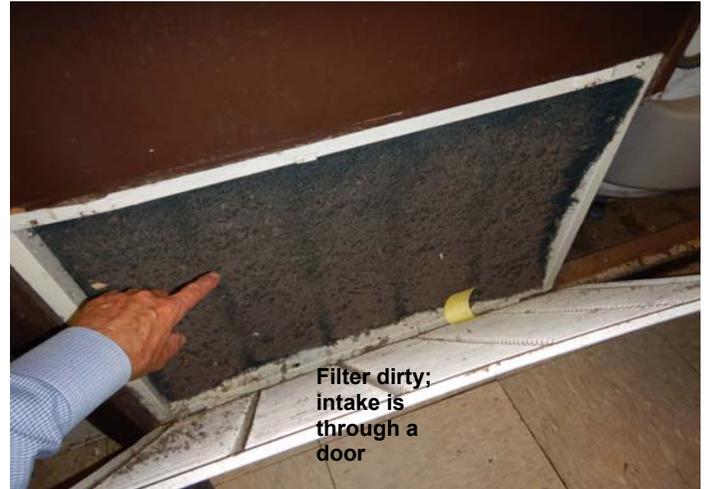
utility closet. The inspected furnace in 39 Cole was functional but was improperly installed and included the following defects:

- No outside combustion air to the utility closet (see Water Heaters, above);
- Installed too close to the water heater, which prevents adequate access for service;
- Utility closet doors do not function readily;
- Return air intake extends through a door instead of through a fixed wall;
- Filter was dirty, which impedes performance and which can adversely affect Indoor Air Quality.

A licensed HVAC contractor should thoroughly inspect every furnace and service it to assure safe operation.

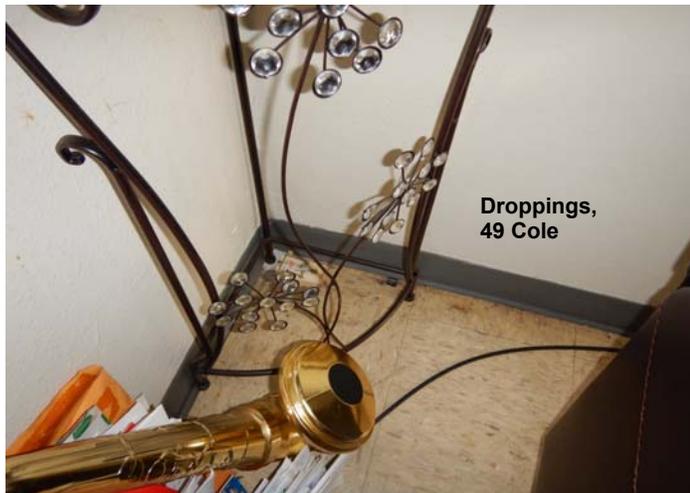
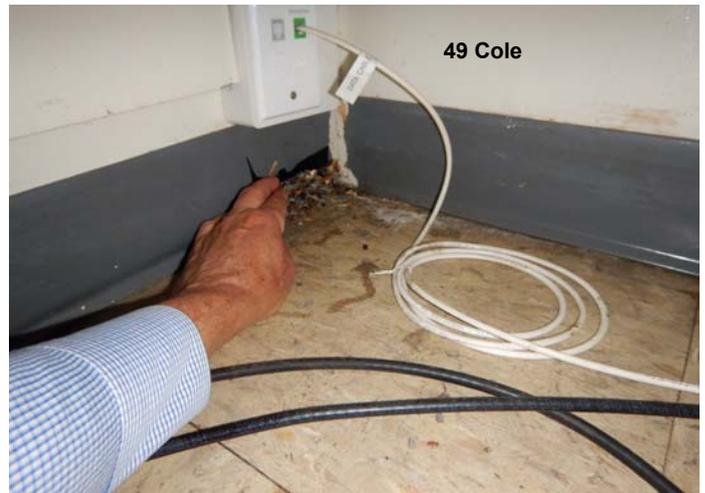
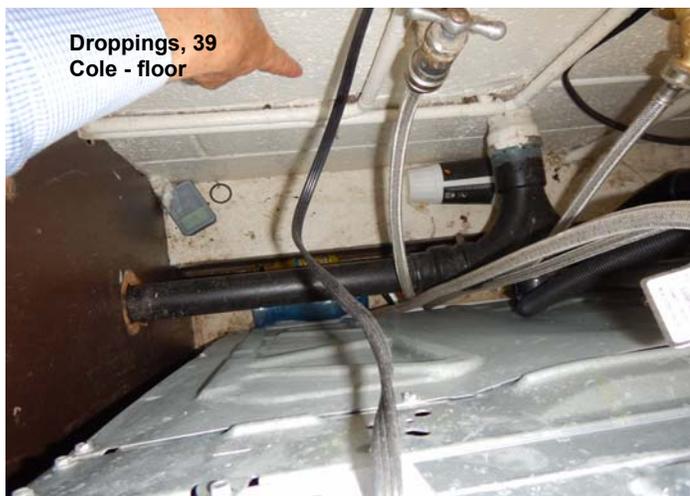
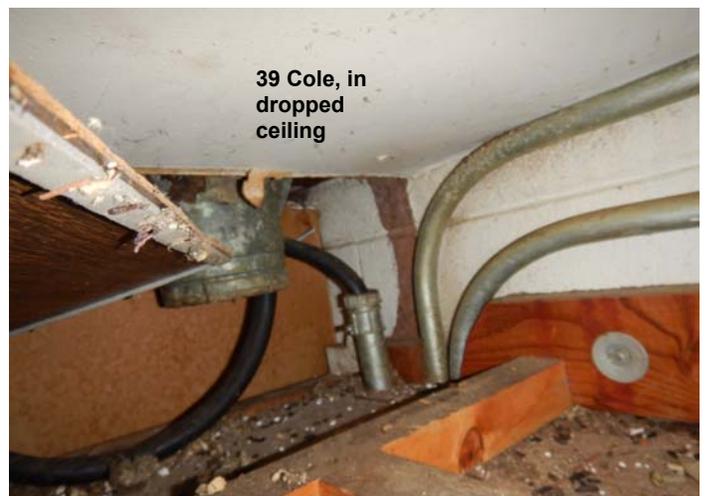
Rodent infestation - Continued

All of the inspected apartments have evidence of active rodent infestation. Rodent droppings are extremely unsanitary and the rodents themselves may carry disease.

A licensed pest control operator should thoroughly inspect and service all of the buildings.

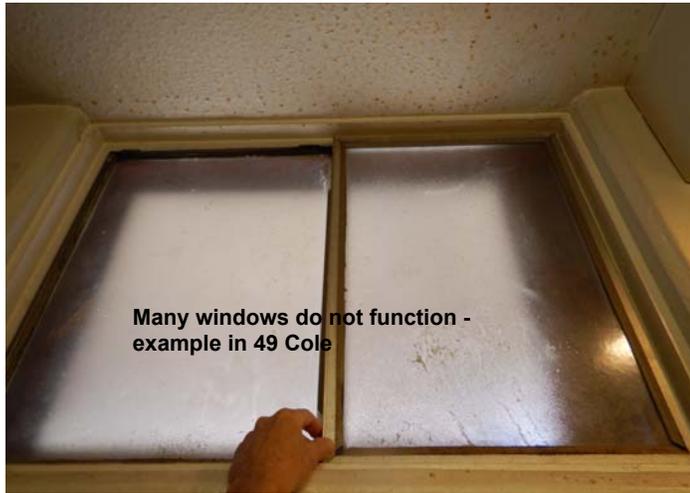
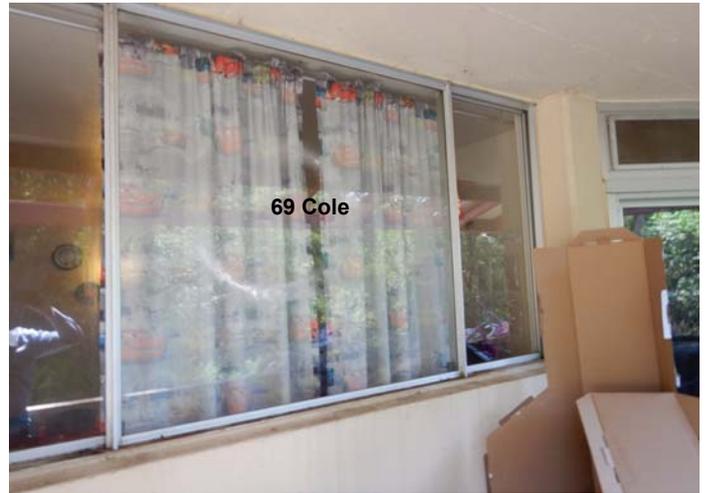
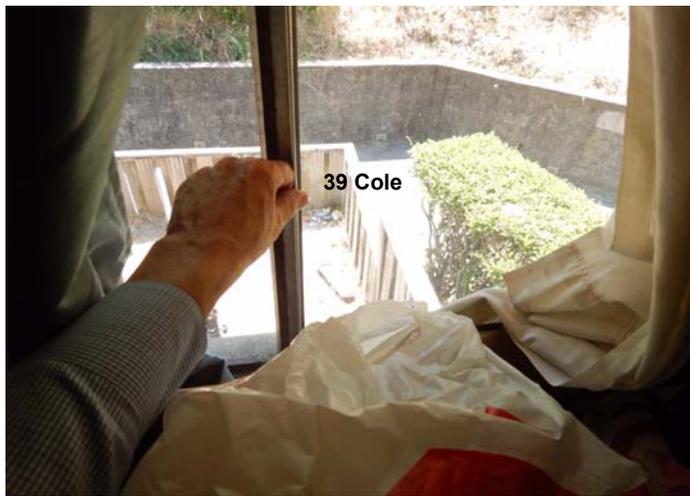
Windows - Continued

Numerous windows in each apartment unit were stuck shut and could not be opened, which violates the fundamental requirements for ventilation and the safety requirements for fire egress.

A licensed glazing contractor should thoroughly repair or replace all non functional windows in order to assure safe occupancy.

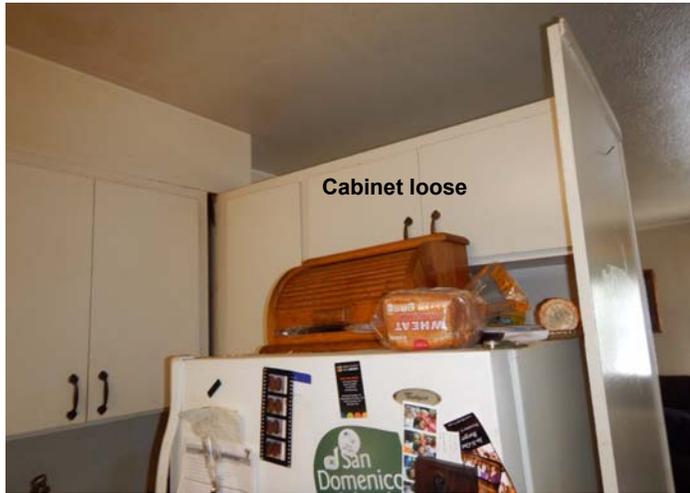
Tall cabinet loose - *Continued*

The tall cabinet behind the refrigerator is loose and should be properly secured so that it does not collapse and cause damage or injury.

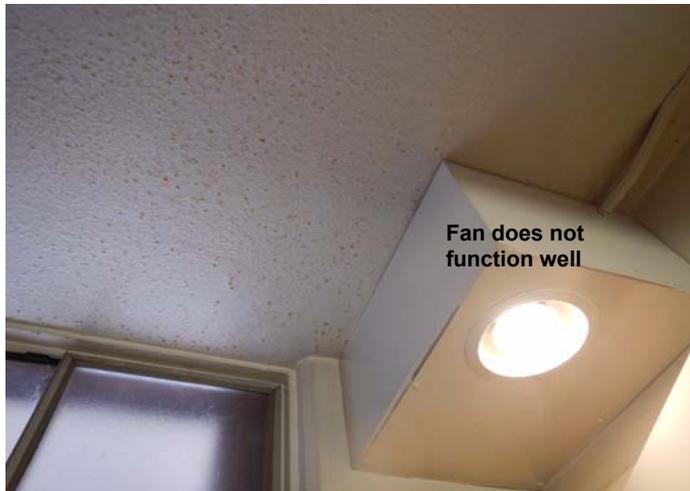
The exhaust fan does not function very well and as a consequence the bathroom ceiling has rust spots and mildew. A licensed contractor should replace the fan.

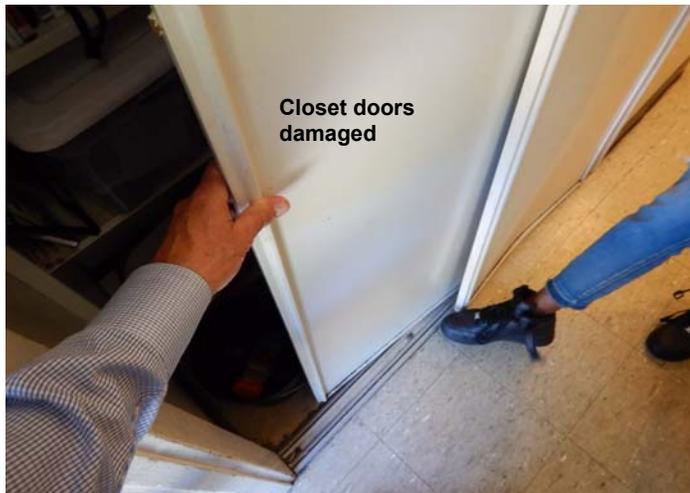
Closet doors damaged - *Continued*

The living room hall closet doors are damaged and should be repaired or replaced.

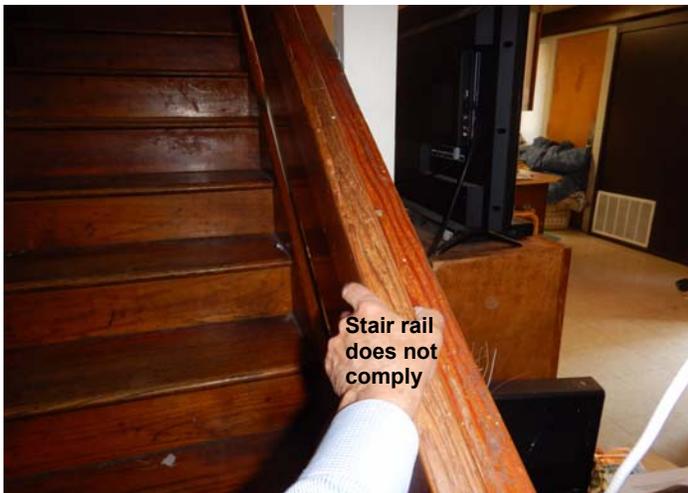
The stair handrail is not graspable as currently required and has no balusters or filler rails beneath it, and therefore might not prevent falling. A licensed contractor should modify the railing to comply with current standards.
